I. GENERAL INFORMATION

Service Performed:	Pre-shipment Inspection
Client:	/
Supplier:	Zhejiang Bode Industrial Co.,Ltd
Factory:	Zhejiang Bode Industrial Co.,Ltd
Product Name:	Vehicle
P.O. No.:	/
Item No.:	MC-455
Destination Country:	/
Inspection Date:	26 July 2014
Inspection Location:	Jinhua City, Zhejiang Province, China
Reference Sample:	None

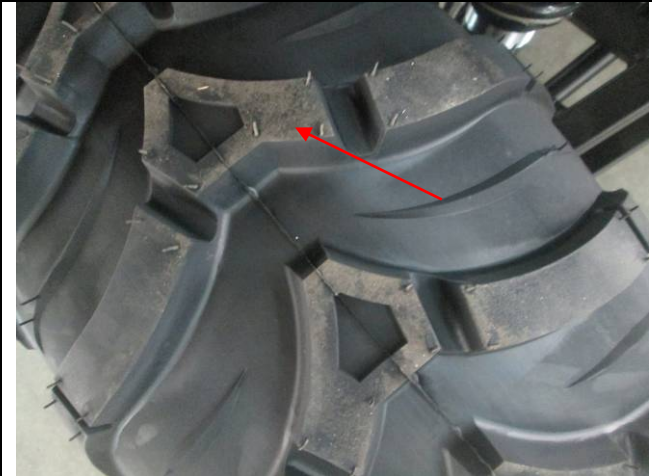
9.	The scratched mark and dirty mark was found on site, the factory claimed that would be repair and clean before packing. Please refer to below photos for details.

<p>Remark 8: the client's Spec.</p>	<p>Remark 9: the scratched mark was found on site, the factory claimed that would be repair and clean before packing</p>

10.	The factory was requested to repair/mend/replace the defective products our inspector found during the inspection.
Factory Information:	
11.	Factory cooperation: <input type="checkbox"/> Good - Enough manpower to assist, and good cooperation. <input checked="" type="checkbox"/> AVERAGE - Enough manpower to assist. <input type="checkbox"/> Poor - Manpower, equipment or document not provided timely.
