1st FINAL INSPECTION REPORT				No.:					
Client/Destination:		Supplier:							
Inspection Date:			Manufacturer:						
Manuf'r Address:			Manuf'	Manuf'r Tel/Fax:					
Article:	Article: Printing Caculator		Order Qty.:		1,000 pcs				
Model No./Brand: 1200.S (CS-1188)/ Spiral Digit		Inspected Qty:		1,000 pcs/50 ctns					
PO No.:	N/A		As'ort / Colour:		Black				
EAN Code:	7898535 760239		S / N Range:		13091200S000001~

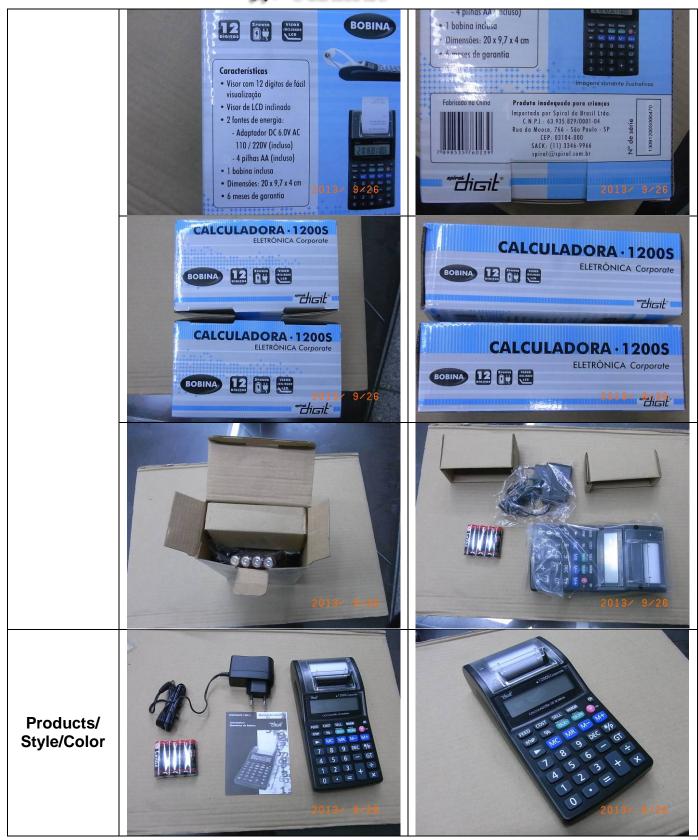
- Factory refused to conduct the carton drop test due to no spares and not required on order.
- c. 0.3A marking on rating label of AC adaptor is different with 0.03A on rating label of back of unit. Pls refer the below photos. That is same as previous shipment.

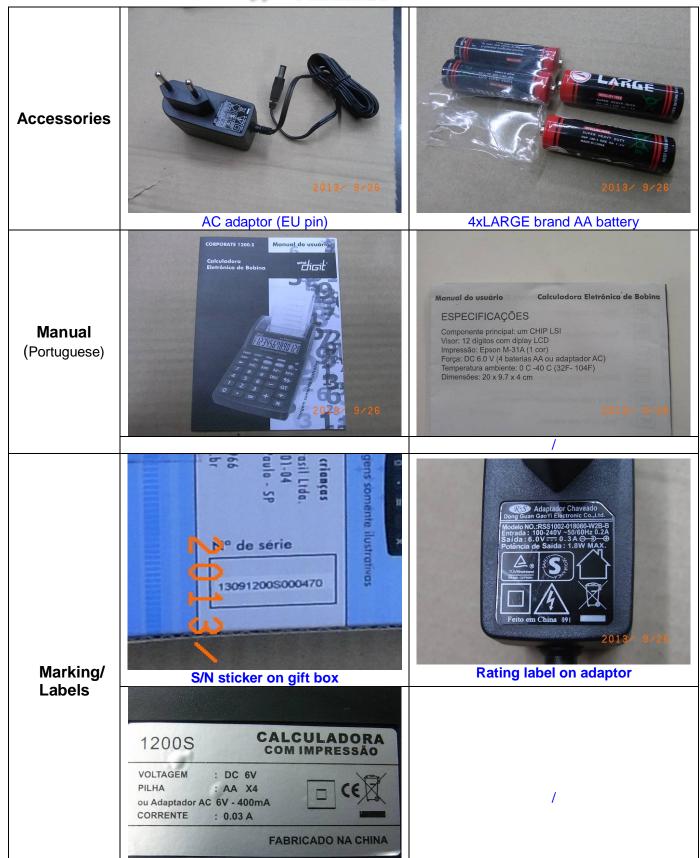
Rating label on unit

d. Only 2.5mm height CE mark on rating label of products (standard requirement: >5mm) that is same as previous shipment.
