I. GENERAL INFORMATION

Service Performed:	Pre-shipment Inspection
Client:	/
Supplier:	Zhejiang Bode Industrial Co.,Ltd
Factory:	Zhejiang Bode Industrial Co.,Ltd
Product Name:	Vehicle
P.O. No.:	/
Item No.:	MC-455
Destination Country:	/
Inspection Date:	26 July 2014
Inspection Location:	Jinhua City, Zhejiang Province, China
Reference Sample:	None

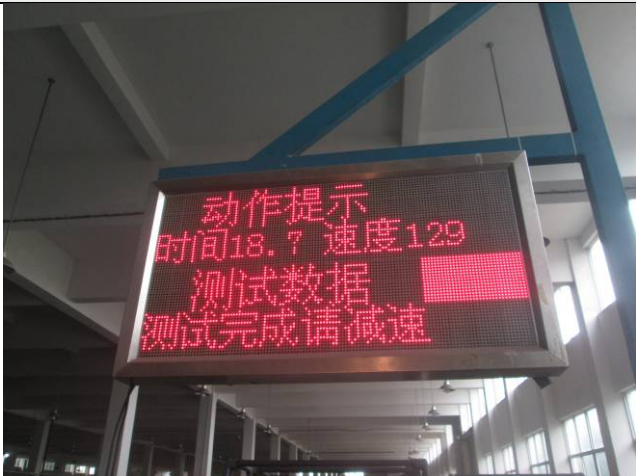
4.	The actual test Max speed was 129 km/h, but it stated on client's Spec. was 85 km/h. Please refer to below photos and Section C for details.
5.	There was no complete finished product was available for dry weight check.

Remark 4: the actual test Max speed was 129km/h	Remark 4: the client's Spec.

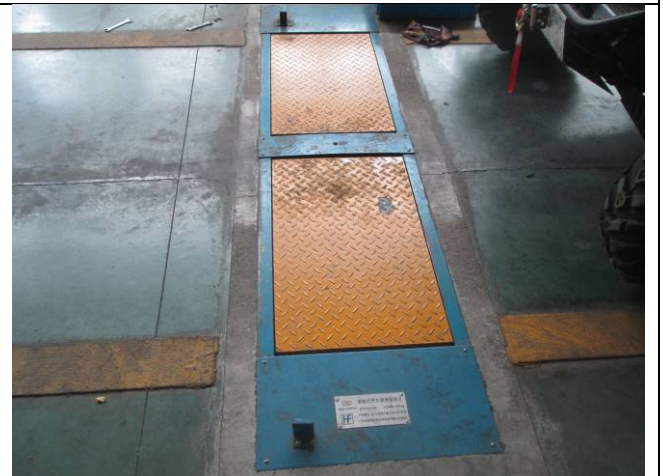
Sideslip test equipment

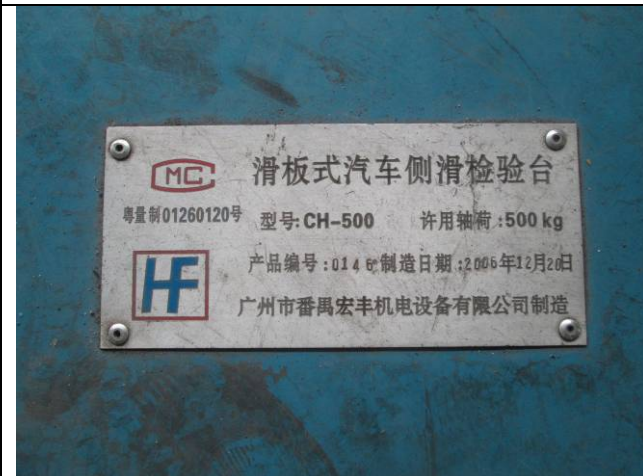
Sideslip test equipment model

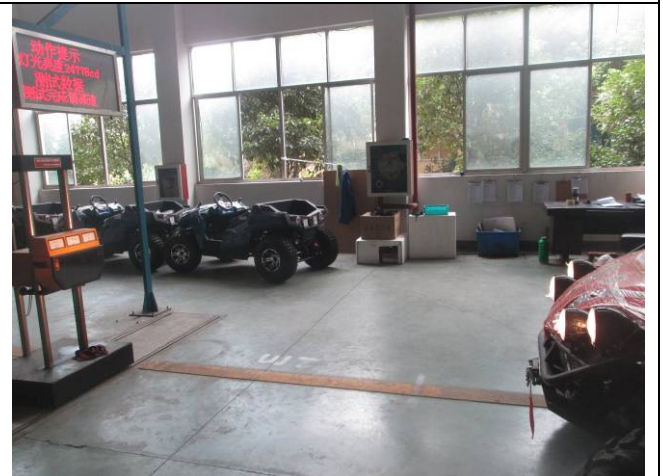
Lamp brightness test
